# SYLWRAP Case Study

## Seawater Cooling Pipe Snapped Nozzle Repair

A petrochemical plant in Saudi Arabia make an urgent repair to a seawater cooling system pipeline after a nozzle snapped off leaving a 50mm hole

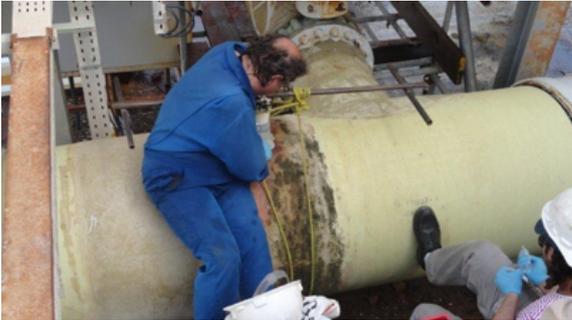
*The pipe surface was damaged and weakened by the five metre jet of water spraying out the 50mm hole*

The 1500mm pipe was the main supply line for a cooling system extracting from the Red Sea. When the nozzle snapped off, it left a 50mm hole spraying water five metres into the air at 3 bar pressure.

Losing so much water impacted the efficiency of the system. It was also causing damage, discolouration and mould to appear where it saturated the line, weakening the exterior pipe surface in the process.

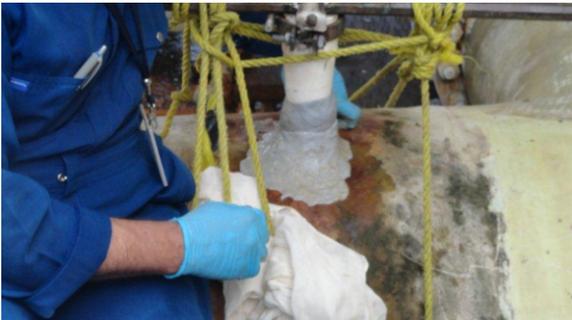
*A PTFE plug secured the hole before being permanently bonded in place using AB Original*

A PTFE plug was fixed permanently in place with **Sylmasta AB Original Epoxy Putty** to seal the hole.

AB Original easily bonded to the wet pipe surface, whilst its two-hour work time allowed for careful application without the worry of the Saudi climate curing off the putty too quickly.

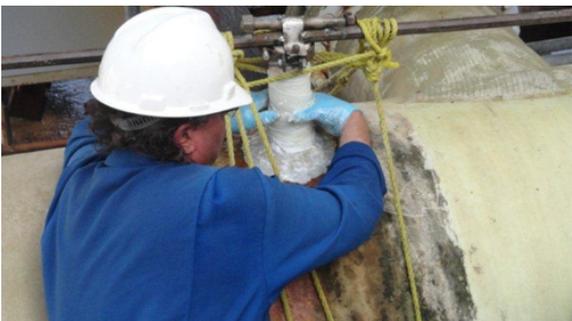
*The exposed top of the PTFE plug was protected by wrapping it in seven layers of SylWrap HD, creating a fully watertight seal*

The exposed top of the PTFE plug was then protected with seven layers of **SylWrap HD Pipe Repair Bandage** for a fully watertight seal.

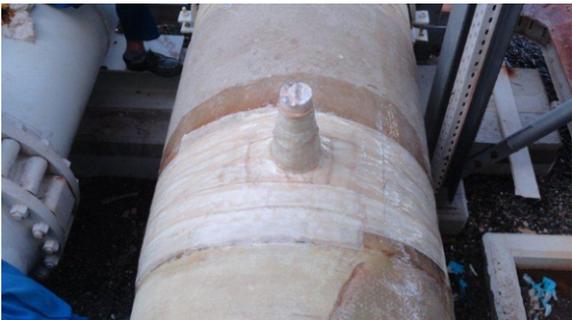
*Further SylWrap HD was wrapped around the pipe diameter, creating a thick and robust outer shell which strengthened the weakened original wall*

When the line was put back into service, water and air were noticed bubbling at the pipe surface near the hole. Four more layers of SylWrap HD were applied around the pipe diameter to reinforce this section.

By the time SylWrap application was complete, the pipe was encompassed in a thick, rock-hard, robust shell strengthening the weakened outer wall.
