SYLWRAP Case Study

Restricted Space Malleable Iron Pipe Repair

A repair is made to a 20mm malleable iron pipe despite space around the leaking section being severely restricted by its close proximity to a wall

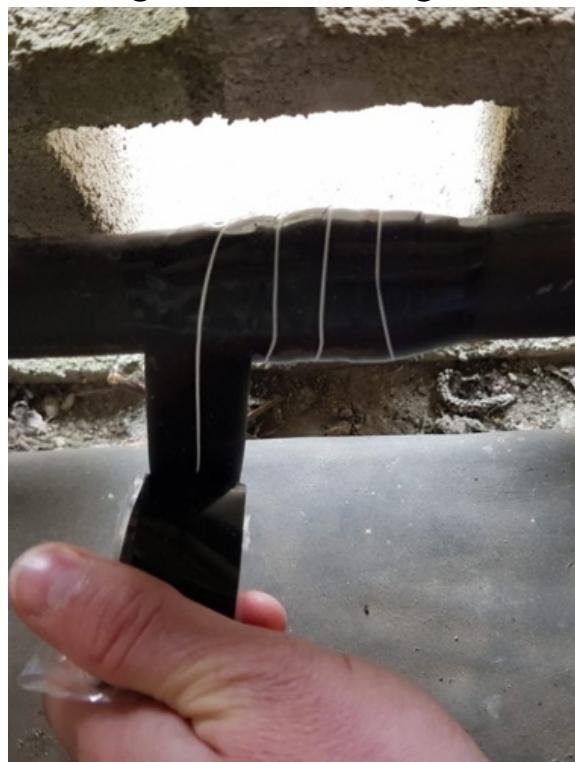
Wrap & Seal was stretched as far as possible by the user into the largest area of space towards them

A small hole had developed where the pipe faced towards a brick wall outside a domestic property.

The property owner held the tape tightly to the pipe with their thumb. They then stretched it as far as possible towards them before pulling it under the pipe and through the space between the pipe and wall.

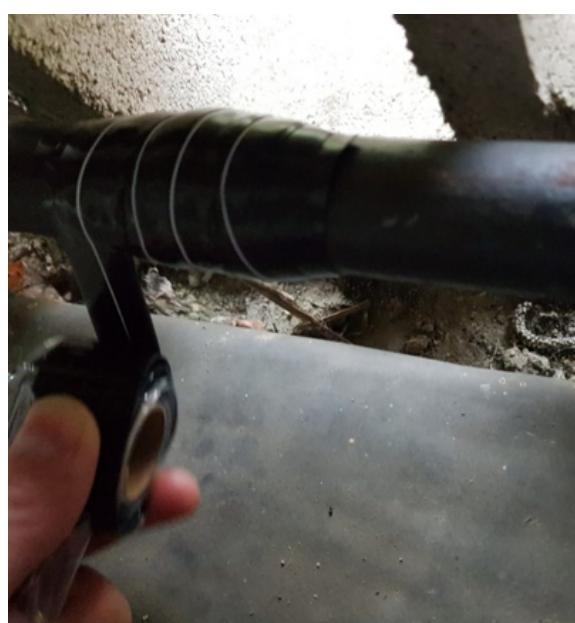
The tape was then pulled under the pipe and up through the 30mm gap between the pipe and the back wall. Despite not being stretched to its limit, Wrap & Seal still amalgamated to form a solid rubber band

Once the first wrap anchored the tape in place, the application continued with a 50% overlap. Each wrap followed the stretch, under and up technique.
