# CERAMIC SUPERGRADE

# Case Study

## Corroded Turbine Cooler Condenser Unit Rebuild

The iron face of a turbine cooler condenser unit deformed by corrosion at a power station is rebuilt to avoid the expensive installation of new parts

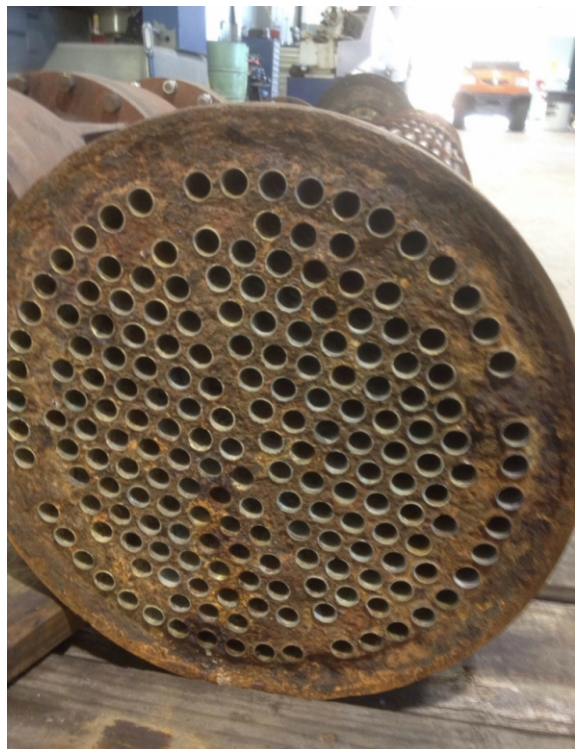
*The cast iron face of the condenser unit was heavily corroded after 20 years of service*

The unit had been condensing steam into water for 20 years at an electrical power plant operated by the Puerto Rico Power Authority. After such long service, the cast iron face had been deformed by corrosion.

Sylmasta recommended **Ceramic Supergrade Epoxy Paste** to rebuild the damaged face and offer the original cast iron protection from future corrosion.

The condenser was cleaned and rods inserted into every tube hole in the face. This ensured none of the bronze tubes could be inadvertently filled with epoxy paste during the application.

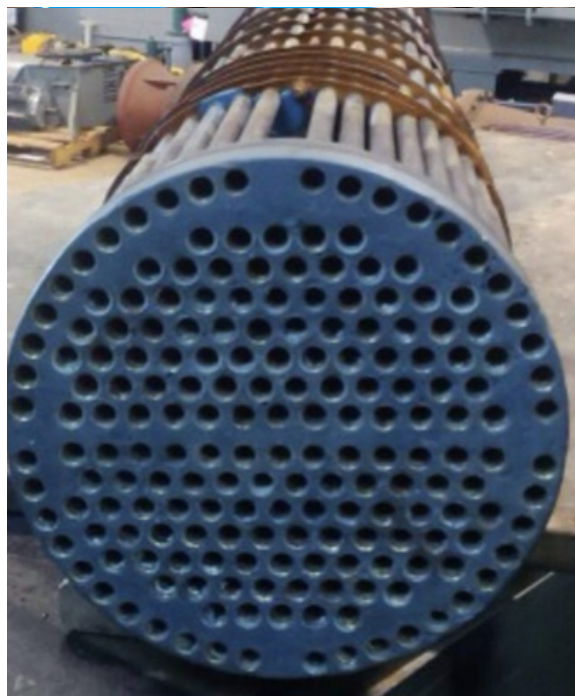
*Ceramic Supergrade rebuilt the face, creating an ultra-smooth surface over the deformed cast iron with high resistance against future corrosion*

Ceramic Supergrade was applied via a hand tool. It filled imperfections in the cast iron and created a new, ultra-smooth, waterproof face over the weakened cast iron with excellent corrosion and abrasion resistance.

A full cure was achieved in 24 hours. The condenser was returned to the turbine and the system put back into operation.
