SUPERFAST STEEL STICK

Case Study

Broken Magic Corner Kitchen Unit Repair

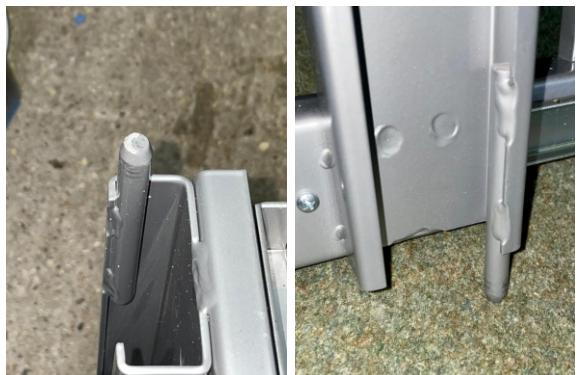
How the pin would have looked when it was welded to the unit before snapping off

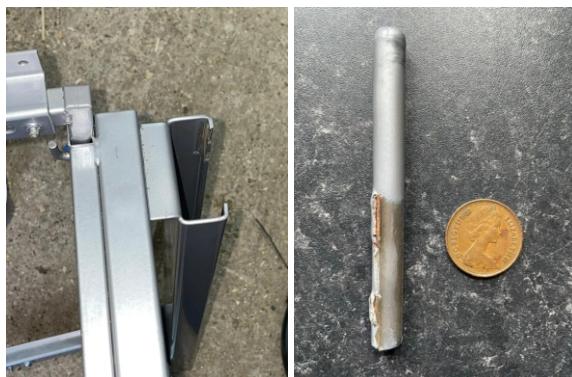
The part of the unit from where the 100mm pin had snapped off and the pin itself after it was detached from the unit

A combination of the age, wear and tear and overloading had caused the magic corner kitchen unit to collapse, detaching it from the cupboard where it had been fitted.

The problem stemmed from a vital 100mm pin which the magic corner pivoted on breaking away from the frame where it had been welded in place.

The pin needed to be reattached to the magic corner using a bonding method strong enough to be comparable with the original welding.

Enough putty for the repair was cut from the stick and kneaded by hand. Whilst soft, it was moulded against the frame to hold the pin back in place.

The putty hardened in around 10 minutes, forming a material as hard as steel to permanently fix the pin back in its original position.

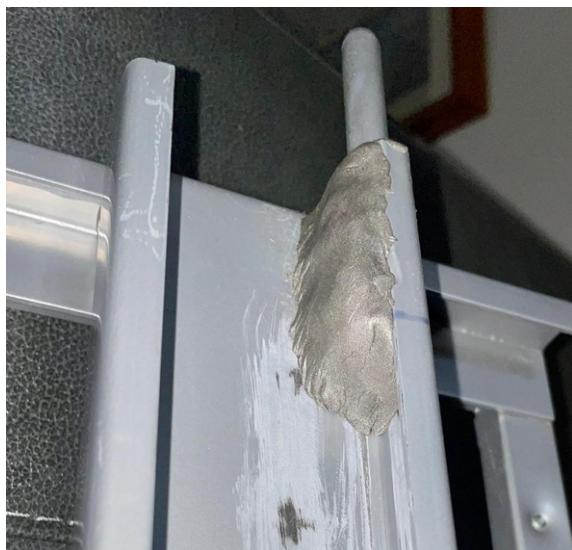
Superfast Steel permanently reattached the pin to the unit, helping the homeowner avoid paying £290 for a replacement magic corner

Within an hour of application, Superfast Steel achieved a full cure and the magic corner could be filled - not overfilled - with items again.
