SYLWRAP Case Study

Mexico Wastewater Plant Pipe Repair Programme

A wastewater plant in Mexico use the Sylmasta Pipe Refurbishment System to repair and strengthen a steel pipeline left leaking and weak in numerous places

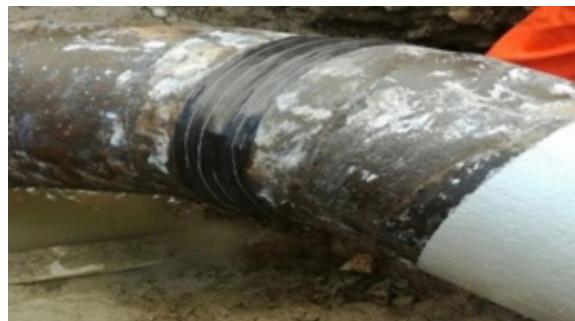
Wrap & Seal was used to repair a leak on an elbow bend which could not be isolated

One area of the pipe which could not be isolated was weeping around an elbow. **Wrap & Seal Pipe Burst Tape** was wrapped around the elbow, fusing to form a solid rubber band containing the live leak.

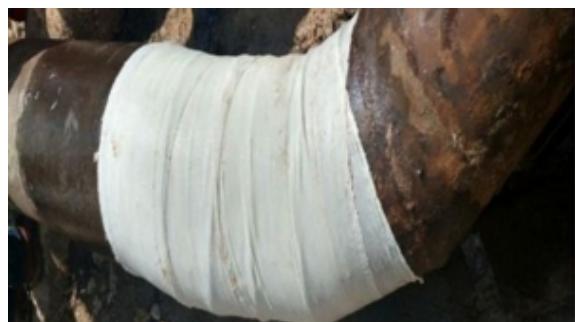
SylWrap HD reinforced the Wrap & Seal repair

SylWrap HD Pipe Repair Bandage was then applied over the tape, providing an impact-resistant protective sleeve to reinforce the repair.

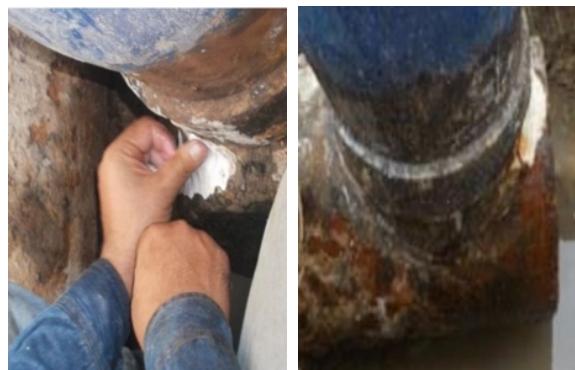
Superfast Aqua PW sealed a tee-joint by filling all gaps in the connection with a rock-hard material

A leaking tee joint was filled with **Superfast Aqua PW Epoxy Putty**, which formed a rock-hard, waterproof material sealing the gaps in the connection.

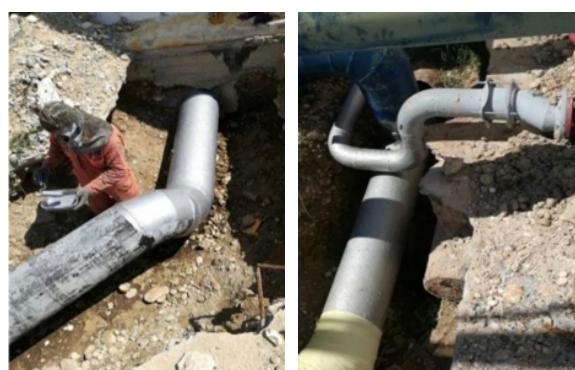
Liquid Metal created a new outer surface protecting and strengthening weakened areas of the pipe

Finally, **Liquid Metal Epoxy Coating** was painted onto weakened sections. It created a new metallic outer surface strengthening the original pipe exterior.
