Industrial Metal Case Study

Metal Drill Base Stand Large Gouge Repair

An engineer refurbishes a second-hand drill base by rebuilding a deep gouge in the metalwork using Industrial Metal at a fraction of the cost of buying a new stand

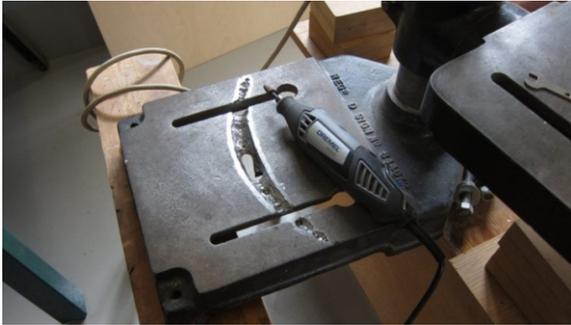
A deep gouge had breached the base stand all the way through because of the previous owner allowing the drill to penetrate the metalwork during use

The previous owner of the stand allowed the drill to frequently penetrate the base, eventually leading to a deep gouge breaching the metalwork all the way through. Due to the damage, they decided to sell.

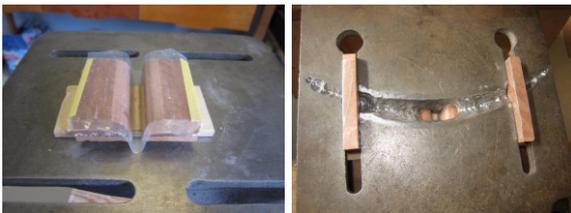
Wooden plates were used to prevent Industrial Metal falling through the gouge to the floor or curing in necessary gaps in the base

A wooden plate was placed underneath the base to prevent paste falling to the floor during application. Further wood was used to ensure necessary gaps in the base were not inadvertently filled with paste.

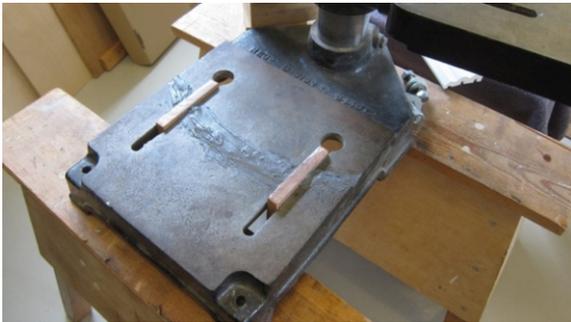
Industrial Metal was applied by hand tool, leaving the gouge fully filled and successfully rebuilt

Industrial Metal was pushed into the gouge using a hand tool until totally filled. The 60 minute work time allowed for careful, accurate application without rushing over fears the paste would set too quickly.

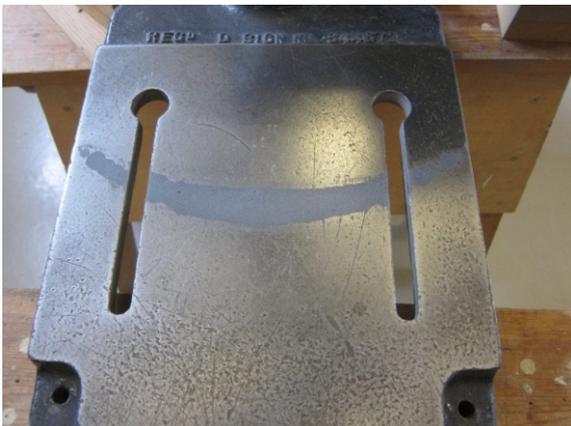
The cured material was sanded down for an ultra-smooth finish seamless with the stand

A full cure was achieved in 24 hours, after which the cured metallic material was sanded down to leave an ultra-smooth finish seamless with the rest of the base.
